Wise Buy Inspection

1403 S Meadow Dr
Monticello IN 47960

Prepared for: Joel Blanton Sr

Prepared by: Wise Buy Inspection
204 W Main St
Rossville, IN 46065
765-379-9810

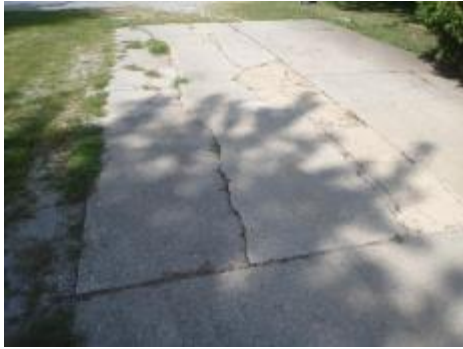
| 7. Maintenance | Driveway: Concrete ; Heavy cracks in surface |

#1 Heavy cracks in surface

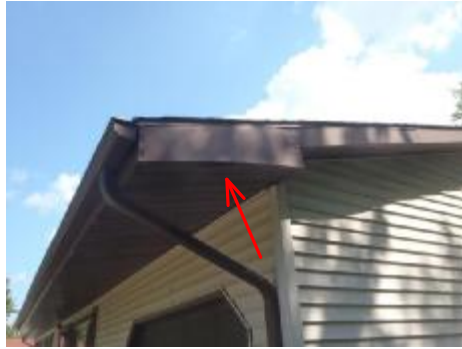
| 3. Maintenance | Fascia: Aluminum - Loose on south end in 2 areas. |

#2 Loose on south end

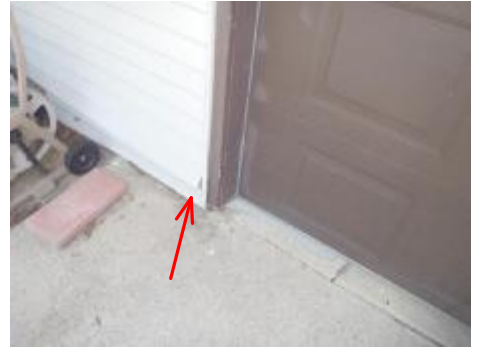
| 1. Maintenance | Type: Vinyl Siding - Loose by garage door |

#3 Loose by garage door

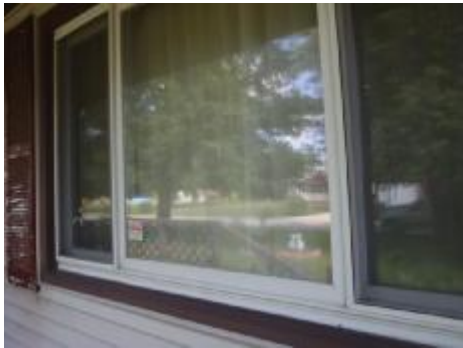
4. All Living Space Windows: Double Paned; Double paned window has lost the thermal seal and is fogging over.

#4 Double paned window has lost the thermal seal and is fogging over.

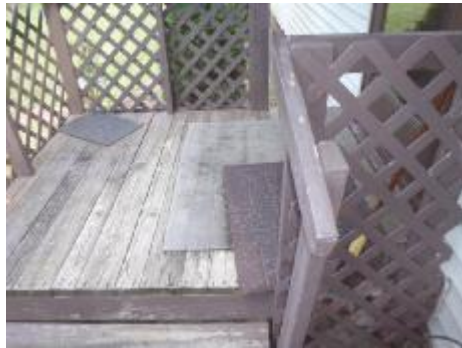
#5 Clean and reseal

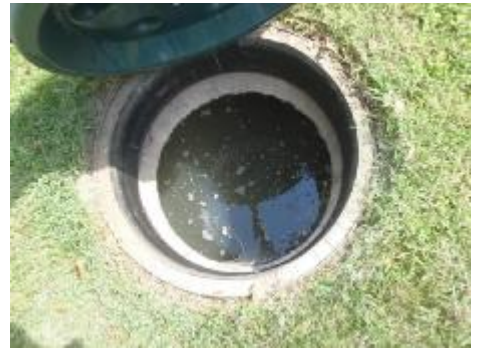
#6 Cover for septic needs to be secured.

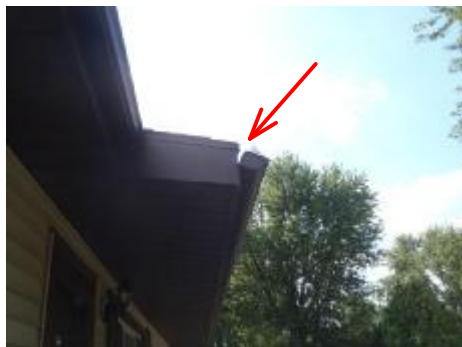
#8 Loose above front porch

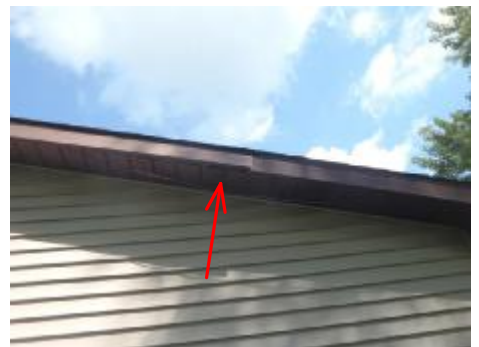
#9 Loose fascia

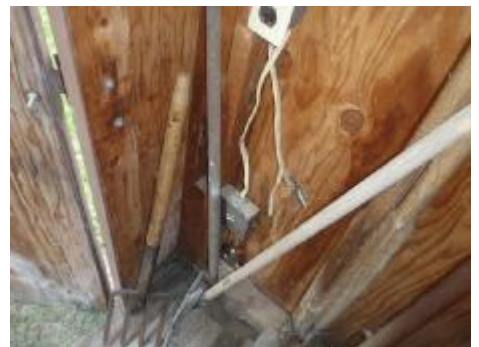
#12 Wired inside but does not have a feed wire

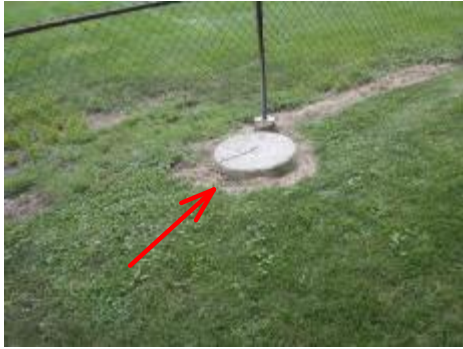
#13 Lid for septic?

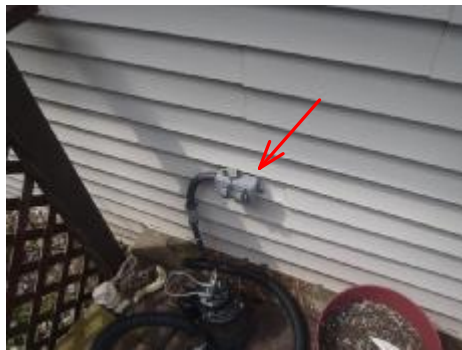
#17 Recommend Exterior outlet be GFI protected

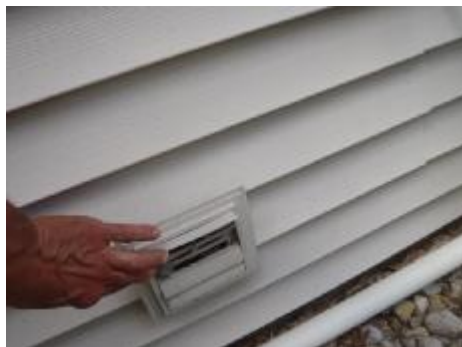
#20 Outside baffle is not to have a screen or grid on it that will restrict air or lint.

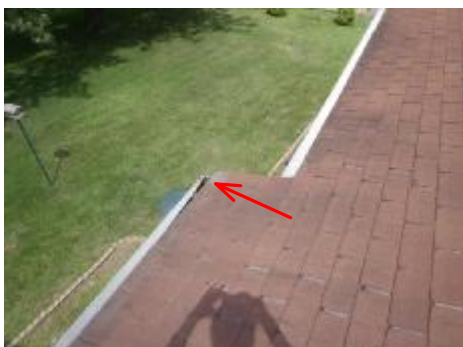
#22 Loose gutter

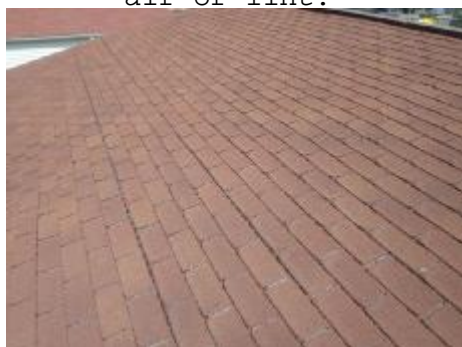
#23 Curled shingles

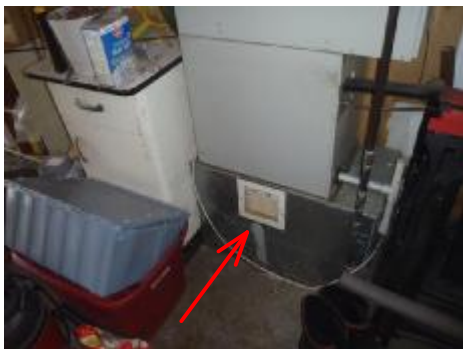
#31 Heat grill should be self closing.

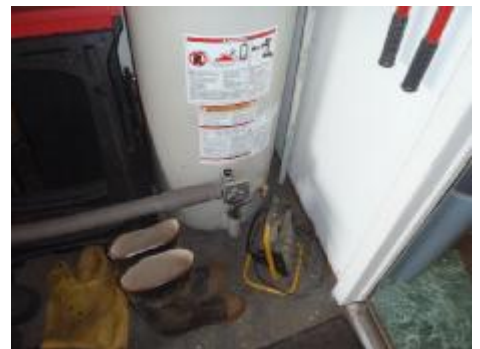
9. Unacceptable Water Heater Operation: Adequate; The water heater needs to be 18 inches above the floor.
10. Type: Natural Gas Capacity: 40 gal.
11. Approximate Age: 8 years Area Served: Whole house
12. Acceptable Flue Pipe:
13. Acceptable TPRV and Drain Tube: Noted but NOT tested

#33 The water heater needs to be 18 inches above the floor.

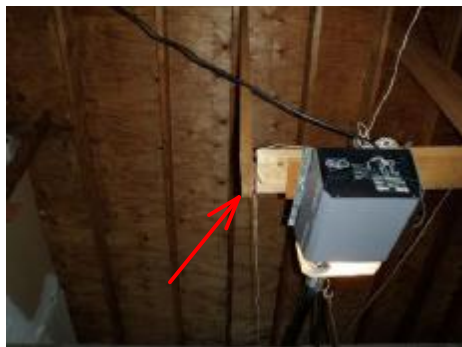
#35 Loose opener support

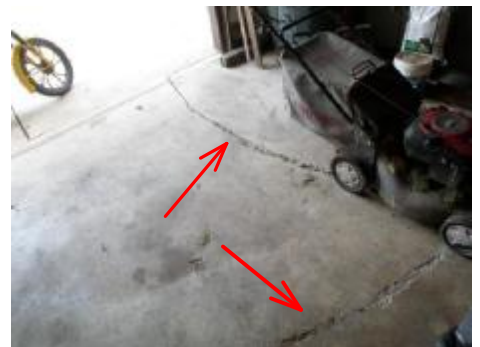
#36 Large cracks

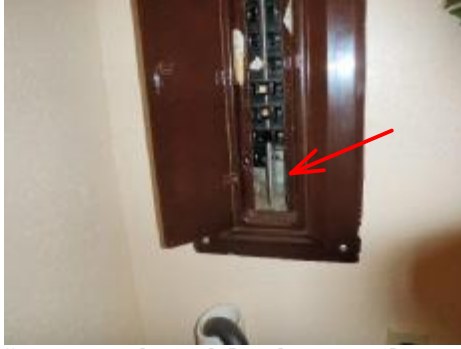
#37 Breaker blanks need to be installed for safety.

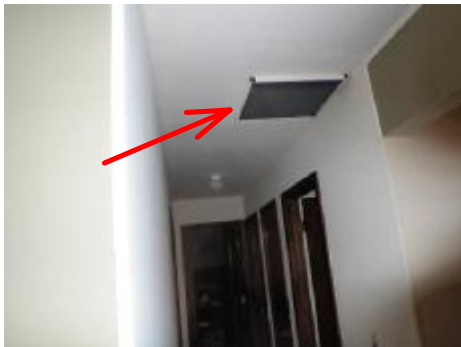
#43 Old furnace filter

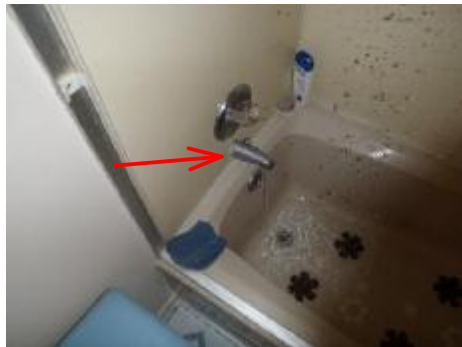
#44 Shower diverter does not direct all of the water to the shower head.

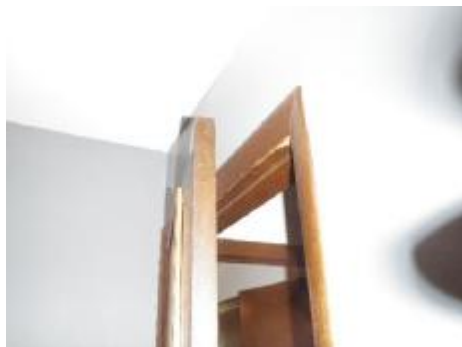
#47 One door needs trimmed at bottom, One needs trimmed at top.

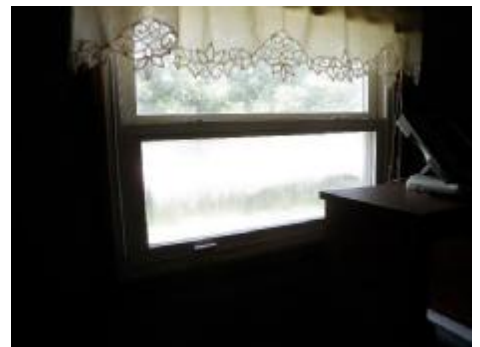
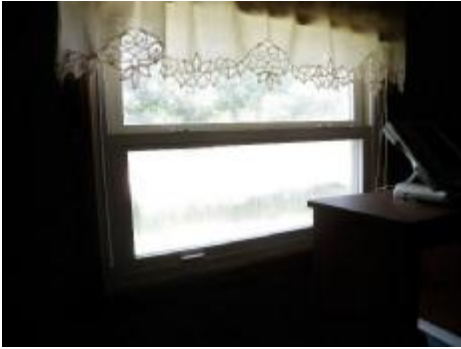
5. All Bedroom Windows: Double Paned; Double paned window has lost the thermal seal and is fogging over X 2

#48 Double paned window has lost the thermal seal and is fogging over X 2

#49 Double paned window has lost the thermal seal and is fogging over X 2

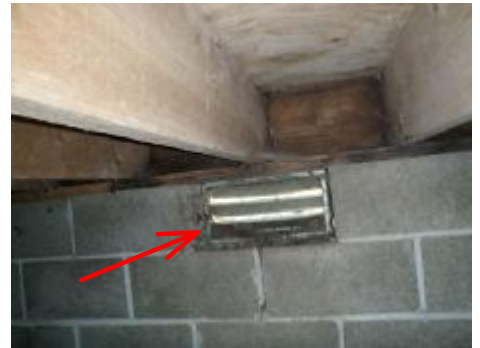
#54 The screens on the vents are torn/ missing and need repaired to keep out mice.

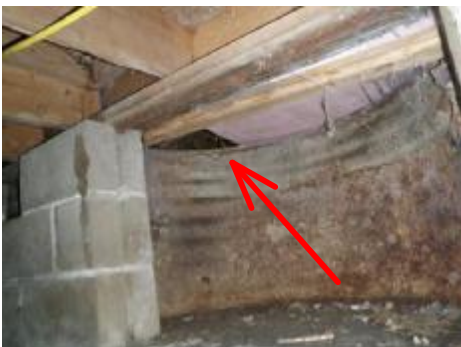
1. Method of Inspection: In Crawl Space
2. Acceptable Unable to Inspect: 0%
3. Unacceptable Access: Access below the deck is allowing coons ect. into the crawl space.
4. Maintenance Moisture Penetration: Yes
5. Moisture Location: Under entire home
6. Maintenance Ventilation: Vents - The screens on the vents are torn/ missing and need repaired to keep out mice.
7. Acceptable Vapor Barrier: 6 ml Plastic;
8. Acceptable Sump Pump: Submerged
9. Acceptable Electrical: 3 hole outlet

#58 Access below the deck is allowing coons ect. into the crawl space.

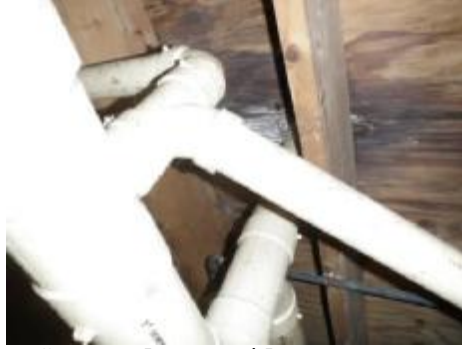
#62 Below toilet. Past leak
