Wise Buy Inspection

216 S Greeley
Mulberry IN 46058

Prepared for: Nick & Shelby Crye

Prepared by: Wise Buy Inspection
204 W Main St
Rossville, IN 46065
765-379-9810

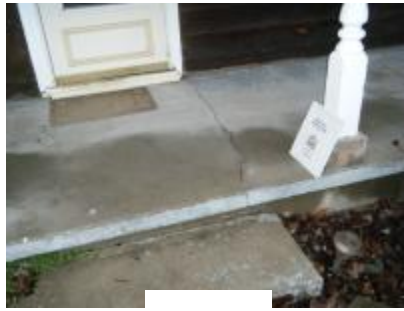
Typical crack

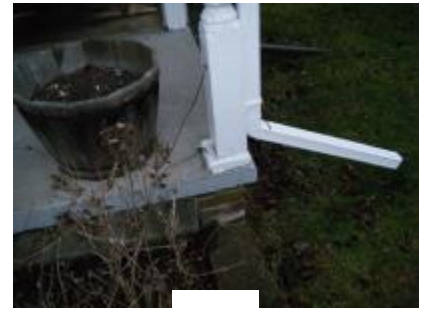
Minor rot

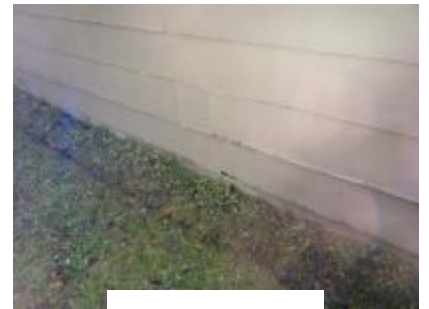
6. West Garage Exterior Surface: Wood - Several pieces are rotted at bottom. Scrape and paint wood fascia

Rotted siding at bottom

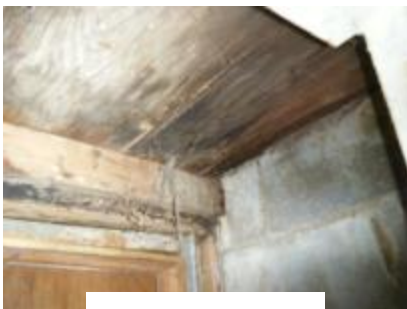
Past leak in wood storage

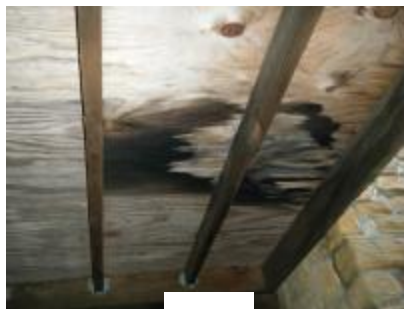
Past leak

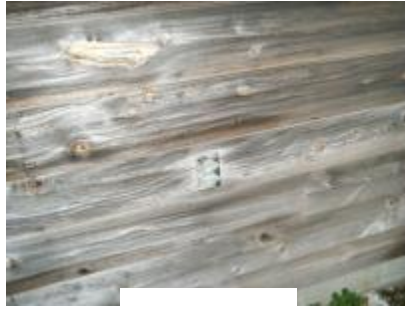
| 12. Maintenance | Exterior Electric Outlets: 3 hole 110 Volt outlets. Recommend all exterior outlets have in use covers and be GFI protected. One outlet did not work |

Outlet did not work

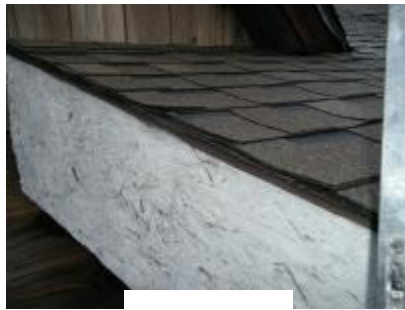
2 layers of roofing

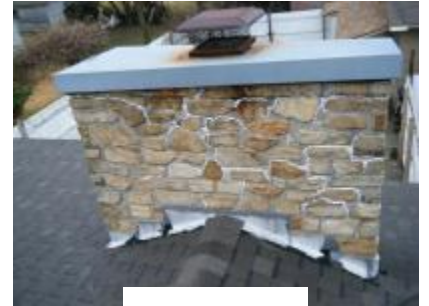
Fill cracks in mortar

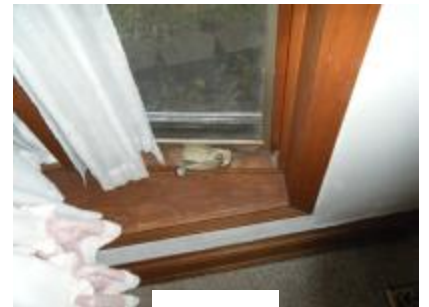
Broken crank

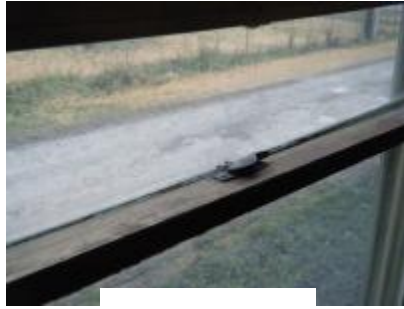
| 6. Unacceptable | Windows: Double Paned; String suspension in master bedroom is broken. East window in master bedroom does not latch |

Window would not lock

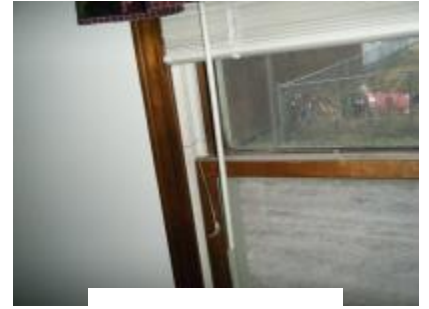
Broken window suspension

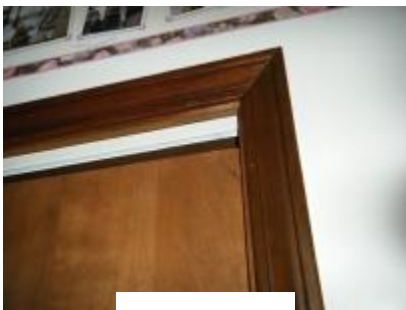
| 1. Maintenance | Closet: Missing door guide on one door |

Missing door guide

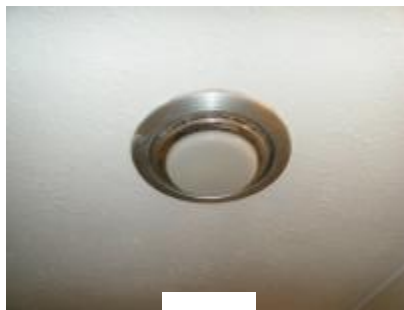
6. Master Bathroom Ventilation: Electric ventilation fan - Fan needs cleaned

Clean fan

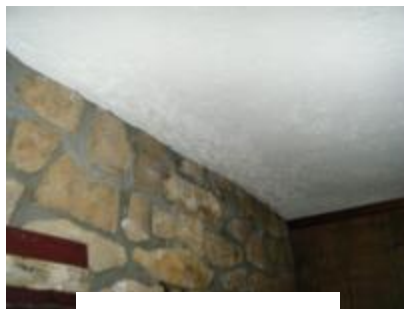
Repaired leak in family room

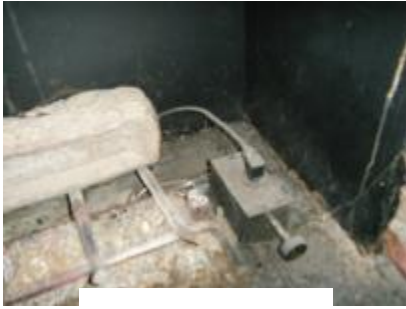
12. Family Room Fireplace Construction: Stone - Clean gas log

Clean fireplace and gas log

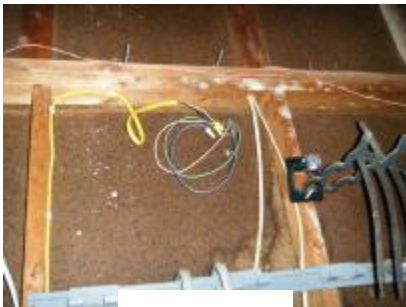
3. West Garage Electrical: 3 hole outlets & 110 VAC lights; There are spliced wires that need to be in a junction box, Recommend garage outlets be GFCI protected.

Install junction box

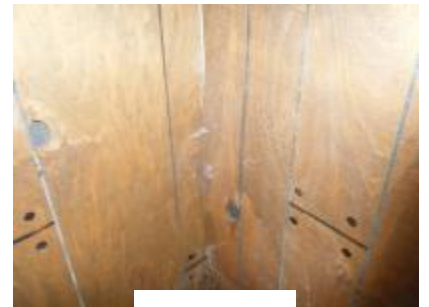
Warped paneling

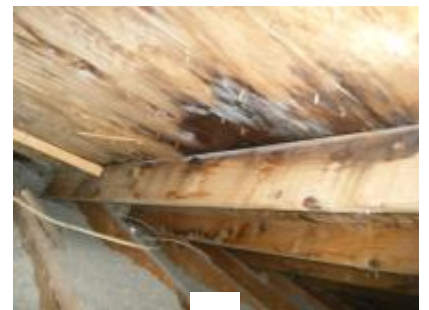
16. Main House Attic Roof Framing: Rafter - The bowed rafters and supports in the attic are stable.
17. Main House Attic Insulation Depth: 8" R-24 - Needs additional insulation above family room by fireplace

Needs additional insulation

Wet

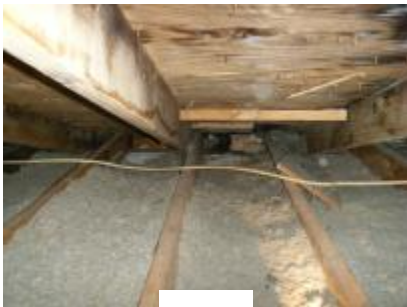
Wet fascia

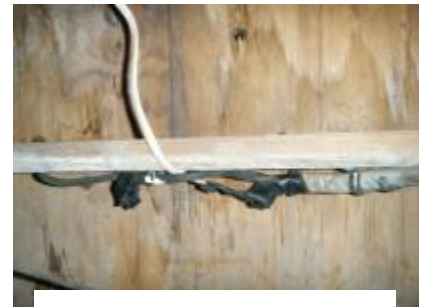
11. Below Main House Crawl Space Electrical: There is a large wire connected to a small # 12 wire. This splice needs to be in a junction box and the breaker needs to be a 20 amp not 125 amp

This # 12 wire in on a 125 amp breaker

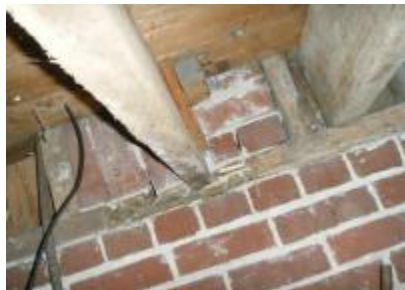
| 6. Maintenance | Joists/Trusses: The termite damage noted is not structurally significant |

Termite damage is not structurally significant
