Wise Buy Inspection

216 S Greeley
Mulberry IN 46058

Prepared for: Nick & Shelby Crye

Prepared by: Wise Buy Inspection
204 W Main St
Rossville, IN 46065
765-379-9810

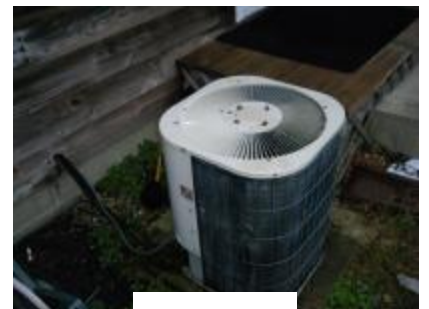
1. Main House AC System A/C System Operation: Central Air - To avoid possible compressor damage due to outside temperature below 60 degrees, the unit was not tested.

AC not inspected
