Wise Buy Inspection

216 S Greeley
Mulberry IN 46058

Prepared for: Nick & Shelby Crye

Prepared by: Wise Buy Inspection
204 W Main St
Rossville, IN 46065
765-379-9810

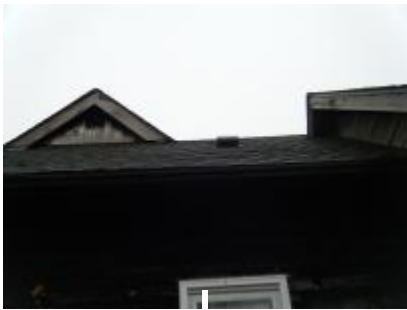
2 layers of roofing

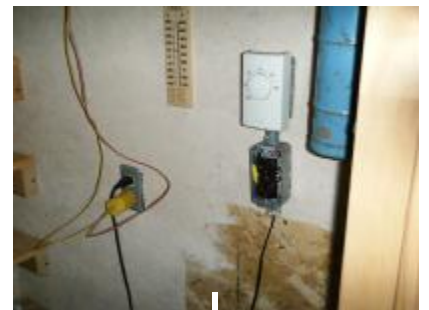
3. West Garage Electrical: 3 hole outlets & 110 VAC lights; There are spliced wires that need to be in a junction box, Recommend garage outlets be GFCI protected.

Install junction box

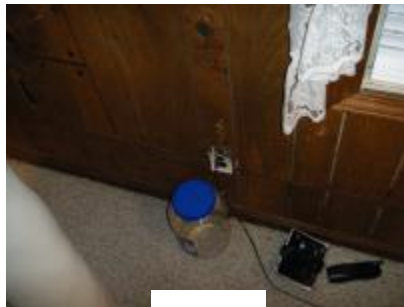
Install cover

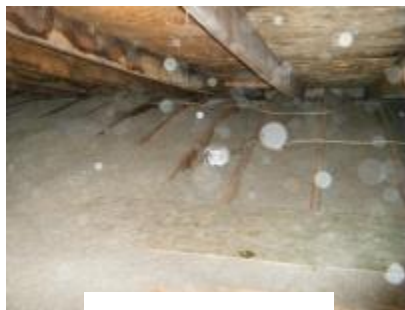
Needs additional insulation

Wet

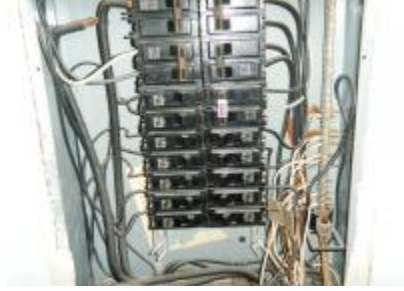
Top LH 125 amp breaker needs to be 20 amp
